# RESEARCH MEMORANDUM

PRELIMINARY INVESTIGATION OF THE HEAT-SHOCK RESISTANT  
PROPERTIES OF MOLYBDENUM DISILICIDE BLADES  
UNDER CENTRIFUGAL LOAD

By Roger A. Long and John C. Freche

May 6, 1952

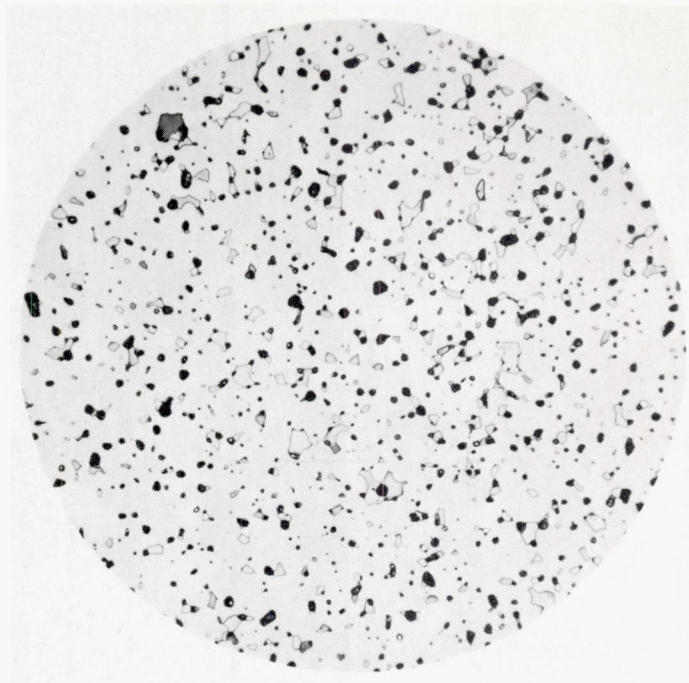
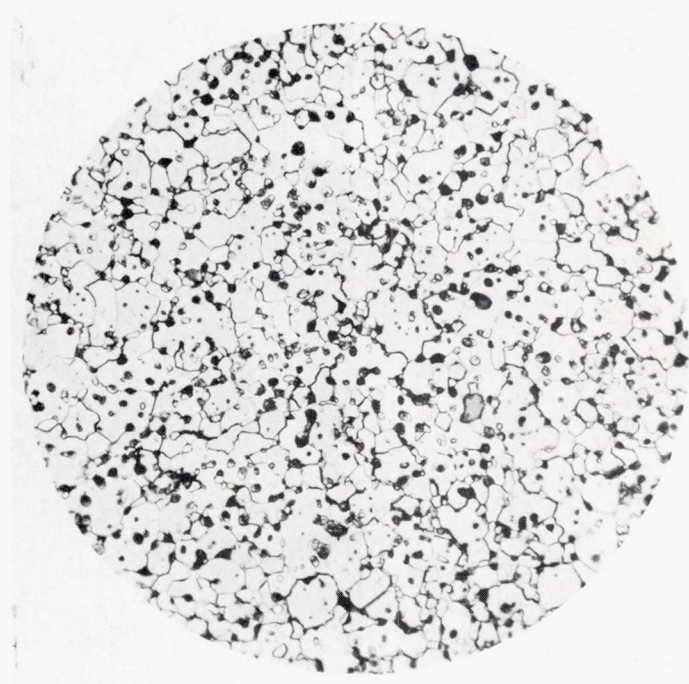
NACA  
C-29092

(a) Unetched; X500.

(b) Etched; X500.

Figure 1. - Typical metallographic structure of molybdenum disilicide blades.

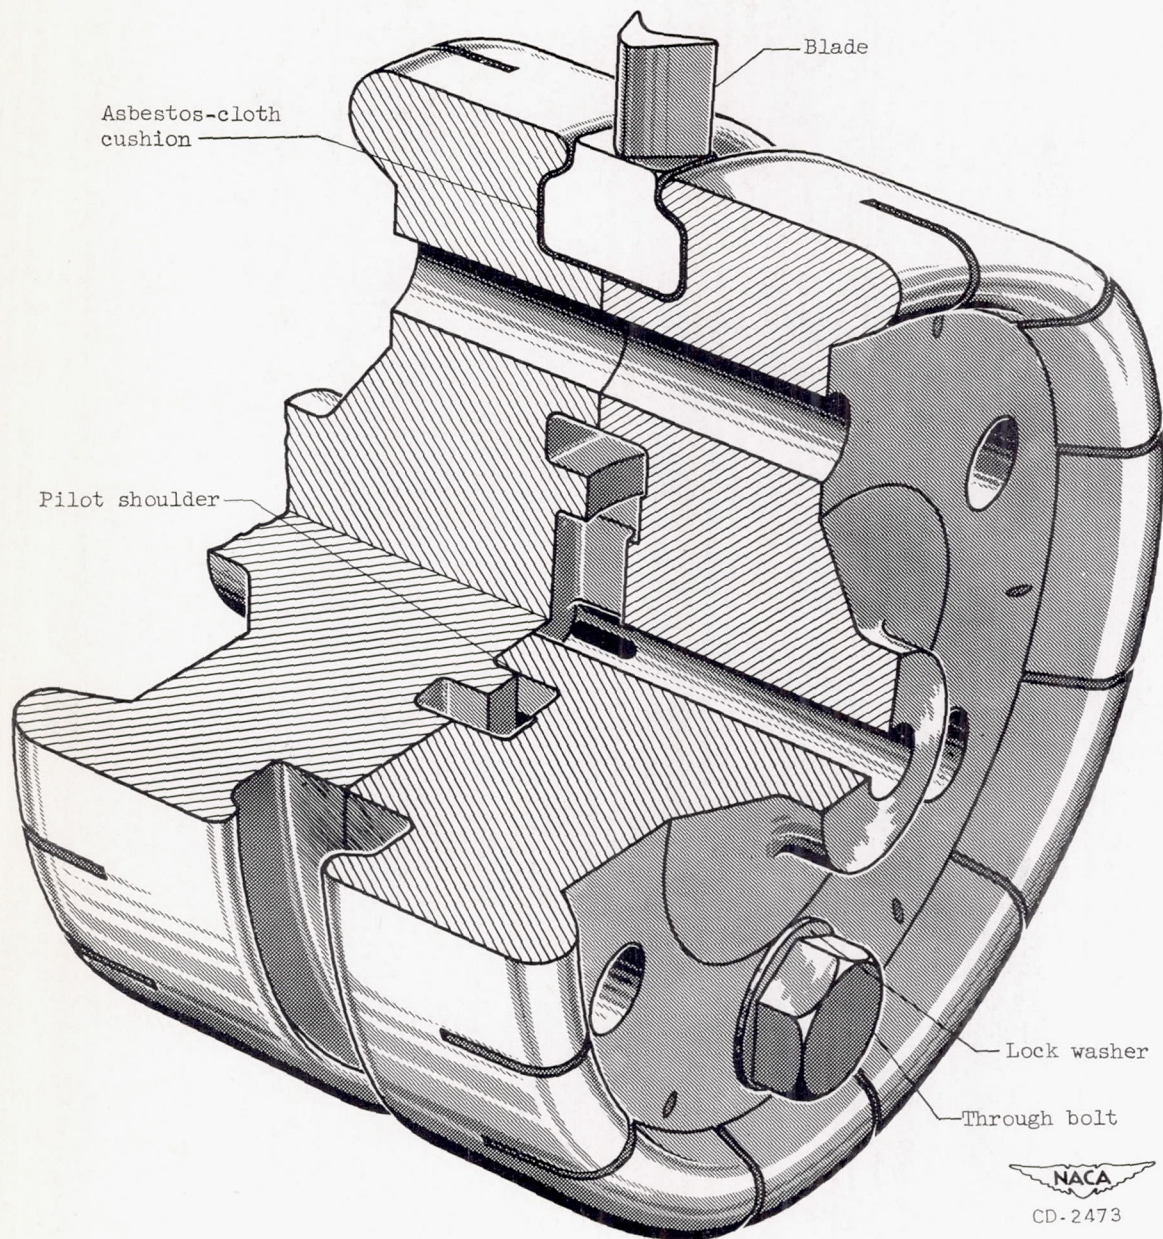
Turbine disks. - The major principles of the disk design as described in reference 1 have been utilized, these being the method of supporting the blades by clamping between suitably contoured surfaces, and providing an overhanging mass of metal at the rim of each disk to resist spreading of the disks. The turbine rotor (fig. 2) consisted of two 9.82-inch-diameter disks, each machined integrally with a portion of the turbine shaft. The two rotor halves were held together by eight through bolts installed at a radius slightly less than the inner radius of the blade-ring assembly. Proper radial alignment between the two disks was obtained by piloting one disk upon a shoulder provided on the other disk.

by compressing the asbestos-cloth cushion (fig. 2) around the blade and caused metal-to-metal contact between the matching disk surfaces. The bolts were then locked to the disks.

Figure 2. - Cross section of turbine rotor.

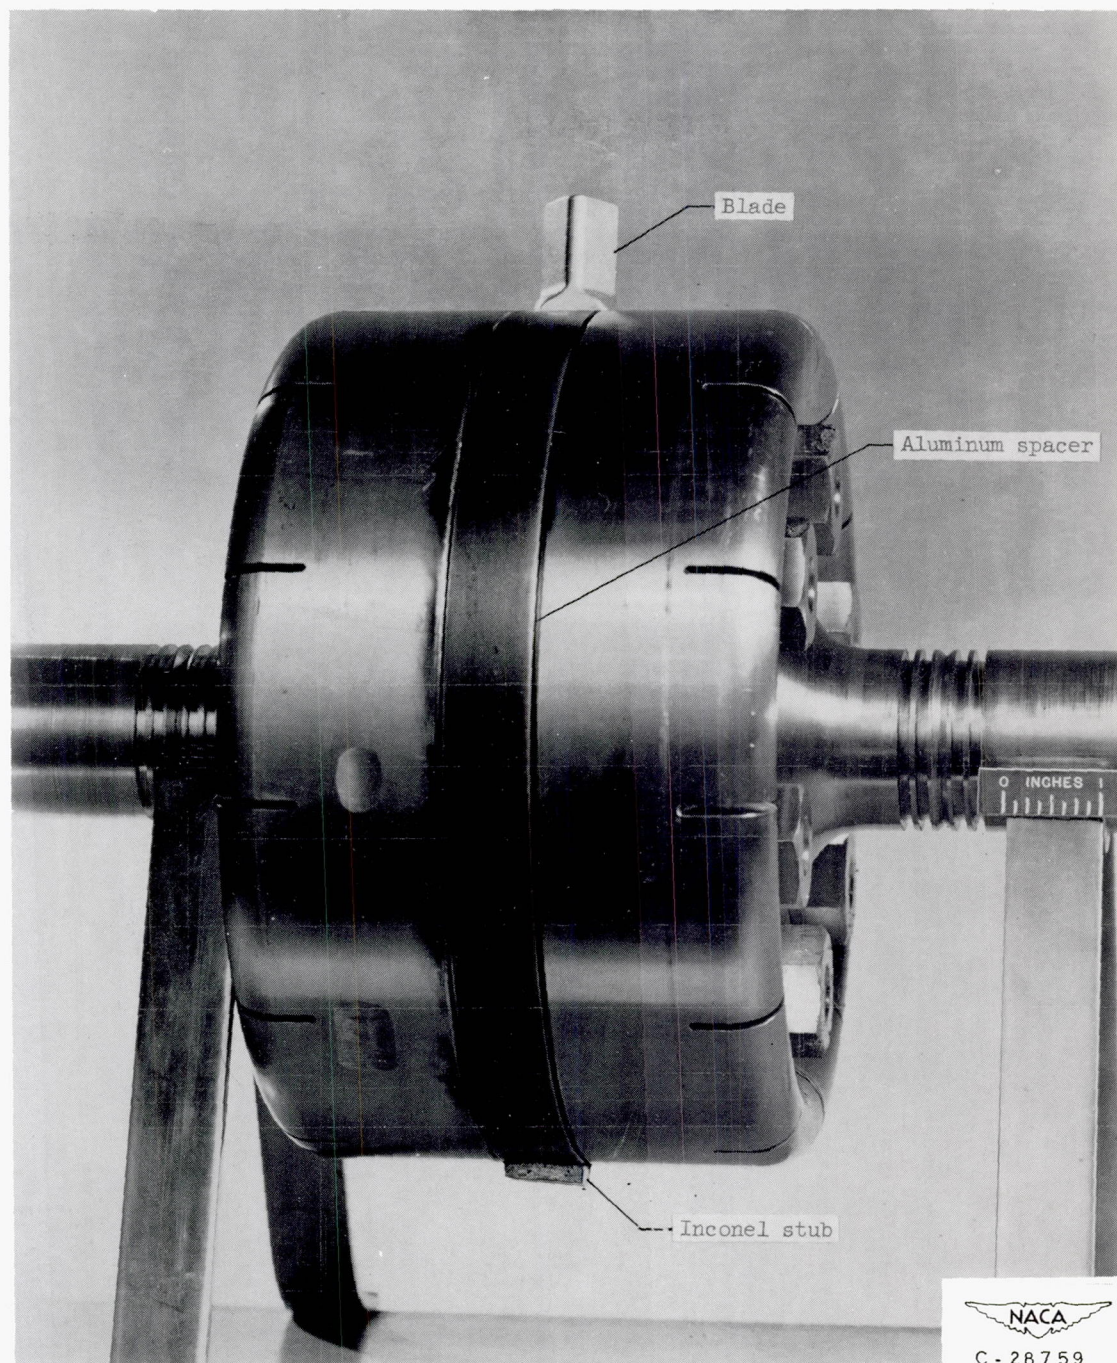
Blade assembly. - Each blade assembly consisted of one blade, one Inconel blade stub, and two aluminum spacers as shown in figure 3. Such an assembly was employed to conserve blades and to lessen the possibility of blade damage by flying chips from an adjacent blade breakage. The aerodynamic section of the blade had a  $1\frac{1}{8}$ -inch span and a 0.840-inch chord. A strip of asbestos cloth was fastened with a quick-drying cement around the base of the blade to reduce the possibility of damage from motion of the blade relative to the metal spacers. A 0.032-inch asbestos-cloth cushion was fastened around the sides and shoulders of the blade base in contact with the disk-clamping surfaces. A blade stub machined from Inconel to the same dimensions as the molybdenum disilicide blade base was employed in each assembly. The Inconel blade stub was clamped between the two disks directly opposite the molybdenum disilicide blade. Metal was removed from the Inconel stub when the rotor was balanced in order to simplify the rotor-balancing procedure. Two aluminum spacers contoured to match the rotor-clamping surfaces separated the molybdenum disilicide blade and the Inconel blade stub.

Figure 3. - Rotor assembly with one molybdenum disilicide blade, an Inconel blade stub, and two aluminum spacers.

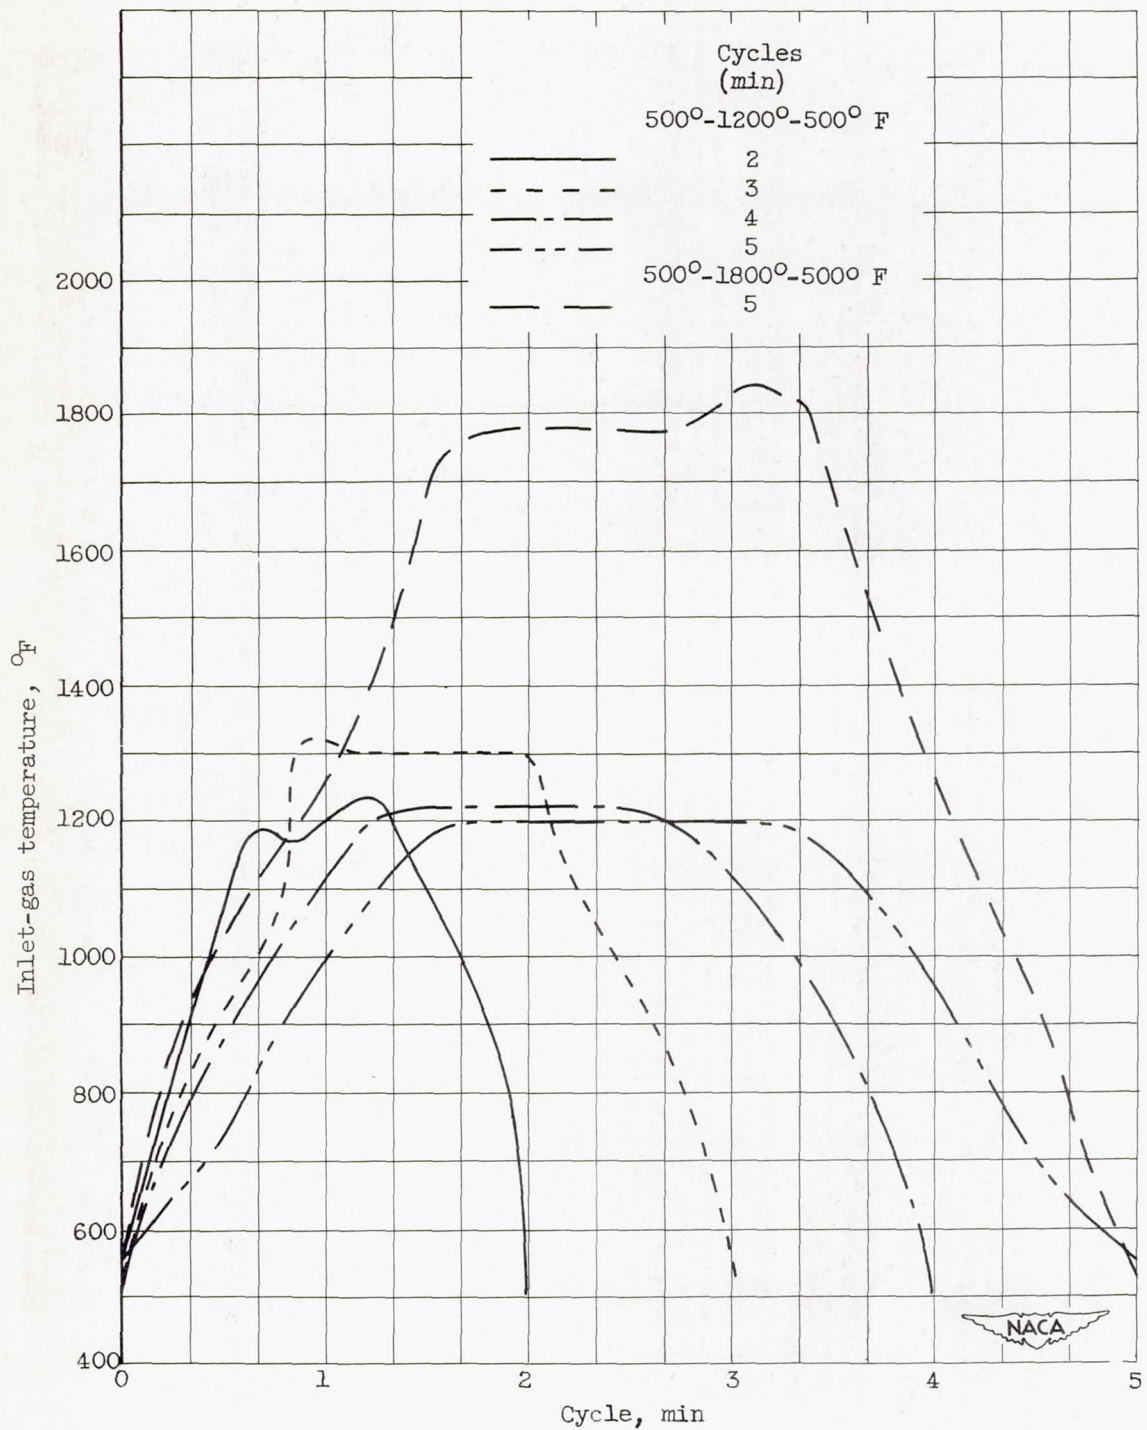
Typical gas-temperature variations with time are shown in figure 4. These cyclic temperature variations were arbitrarily chosen in reference 2. Similar cycles were run in this investigation to permit direct comparison with the heat-shock tests conducted with ceramic blades in reference 2. The gas temperature was varied by manual adjustments of the valve controlling the fuel supply to the burner. A constant rate of temperature increase or decrease was not always maintained, which explains the absence of parallelism in some of the curves.

Figure 4. - Typical rotating heat-shock cycles obtained with blade 2 showing variation of inlet-gas temperature with time. Centrifugal blade stress maintained at 5350 pounds per square inch.

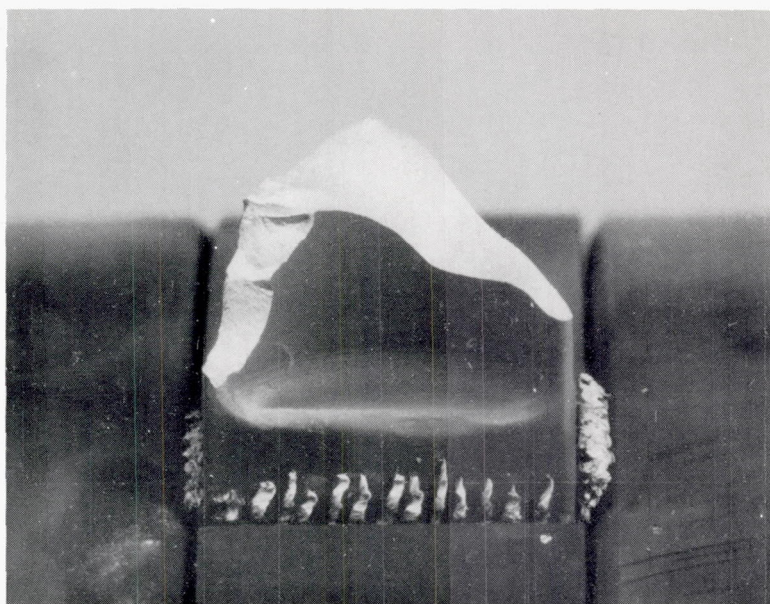
Blade 1 was subjected to heat-shock cycles at three different centrifugal stress levels, 927, 2080, and 3710 pounds per square inch. The minimum change in inlet-gas temperature per unit time for a 500° to 1200° to 500° F cycle, which was imposed at all three stress levels, was a rate of inlet-gas temperature increase or decrease of approximately 7° F per second; the maximum change for this temperature cycle was 17.5° F per second. The minimum change in inlet-gas temperature per unit time for a scheduled 500° to 1800° to 500° F cycle was a rate of inlet-gas temperature increase or decrease of approximately 13° F per second; the maximum change for this temperature cycle was 32.5° F per second. The blade successfully withstood all the heat-shock cycles imposed prior to an unscheduled decreasing-temperature heat shock which occurred during the 5-minute cycle at a centrifugal blade stress of 3710 pounds per square inch. This failure resulted when loss of the fuel supply to the burner created a more drastic heat shock than intended at that time. The inlet-gas temperature decreased from 1400° to 300° F in approximately 3 seconds, a shock similar to but less severe than the decreasing-temperature heat-shock or blow-out cycle deliberately imposed upon the Body 4811C blades investigated in reference 2. It was intended that such a blow-out cycle should be imposed upon the molybdenum disilicide blades after the scheduled cycles had been completed. Examination of the blade fracture surface (fig. 5) indicates that no fatigue failure occurred. Apparently the blade failed either in tension or by heat shock. Since the tensile loadings imposed were well within the allowable tensile strength of the material, it is very likely that failure occurred because of heat shock.

(a) Blade fracture surface. Blade in rotor.

Figure 5. - Molybdenum disilicide blade 1 after failure.

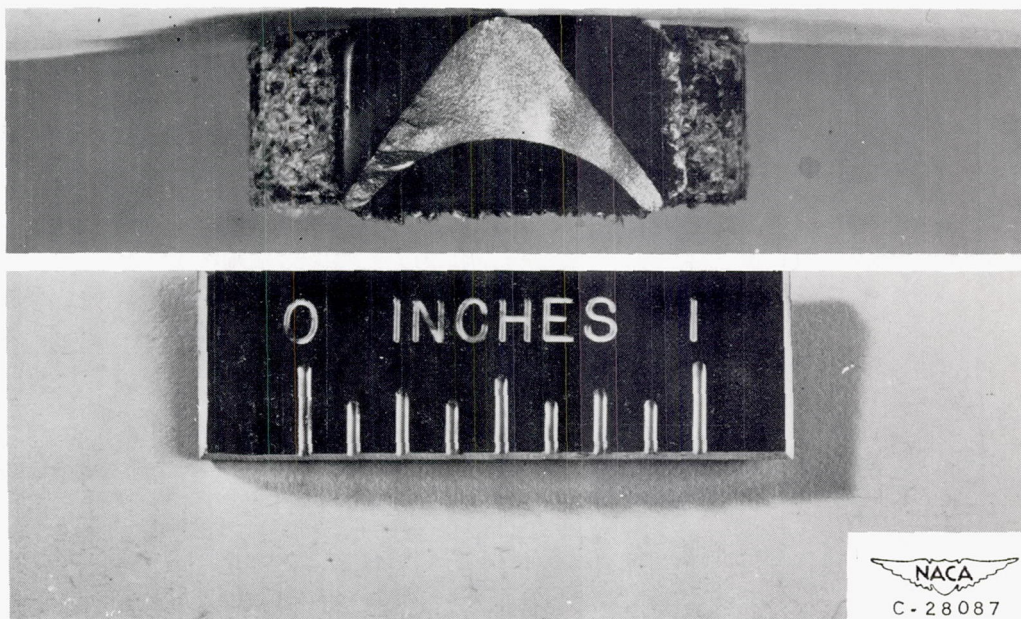
(b) Blade fracture surface. Blade removed from rotor.

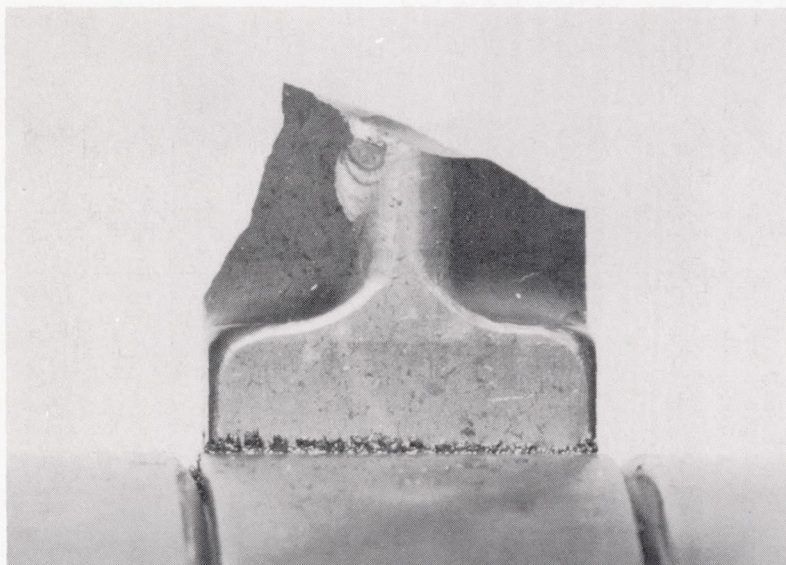
Blade 2 successfully completed all the 500° to 1200° to 500° F cycles under an imposed centrifugal stress of 5350 pounds per square inch. Blade 2 also completed successfully all the 500° to 1800° to 500° F cycles in which the maximum and minimum rates of gas temperature increase or decrease were 21.7° and 13° F per second under an imposed centrifugal stress of 3710 pounds per square inch. Failure occurred between the 5- and 4-minute, 500° to 1800° to 500° F cycles while the blade was centrifugally stressed to 5350 pounds per square inch. The blade after failure is shown in figure 6. Fracture appears to have

originated on the convex surface of the blade (fig. 6(a)). Examination of the origin of fracture indicates a fatigue-type failure (fig. 6(b)). Blade failure can be attributed in this case to one of three possibilities: (1) heat shock initiated a small crack which developed because of fatigue under continued turbine operation, finally resulting in blade failure; (2) impact by a foreign substance initiated a stress concentration and a fatigue failure resulted; or (3) failure resulted from fatigue caused by blade vibration and possibly originated from micro-defects in the blade. The first of these possibilities is considered the most likely one. Blade failure due to impact by foreign materials is considered remote because fine mesh screens were employed in the air duct upstream of the turbine to filter out such substances. The blade design with its short length and thick section probably minimized blade vibrational tendencies.

(a) Blade in rotor showing possible impact fracture area.

Figure 6. - Molybdenum disilicide blade 2 after failure.

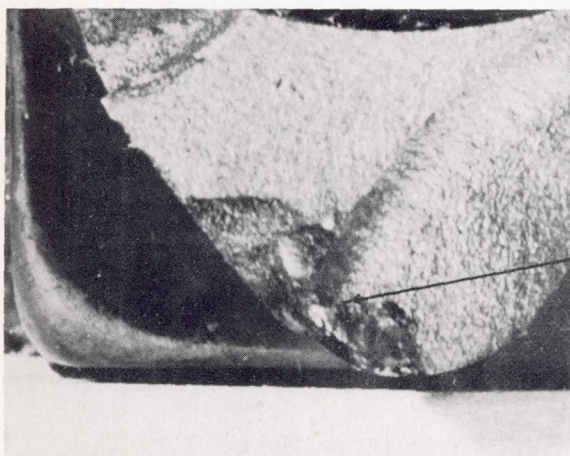
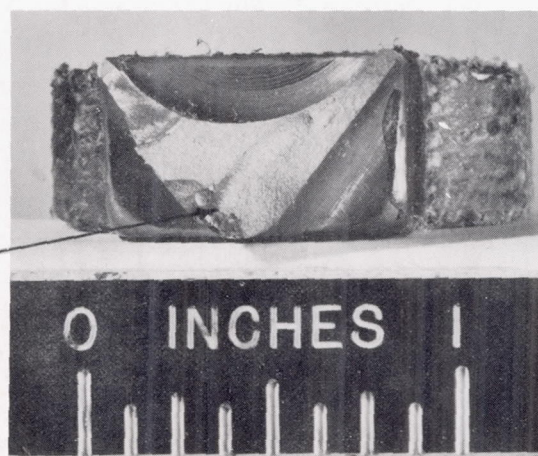
(b) Fracture surface showing possible initial fracture area. Blade removed from rotor.
